## PHOTO DIARY (4)

### St John's day 2004

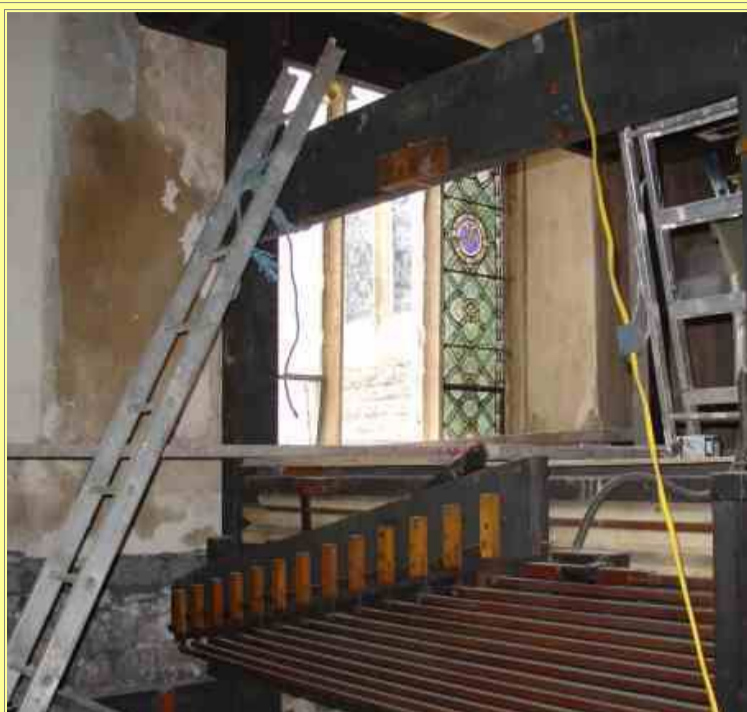
With a couple of wind chests removed, it is possible to work on the wall behind the organ, which has deteriorated over the years, due to water ingress through the windows whose leading has perished. The original 1890s wall plaster has to be replaced, and two of the panels of the window removed to be re-leaded.

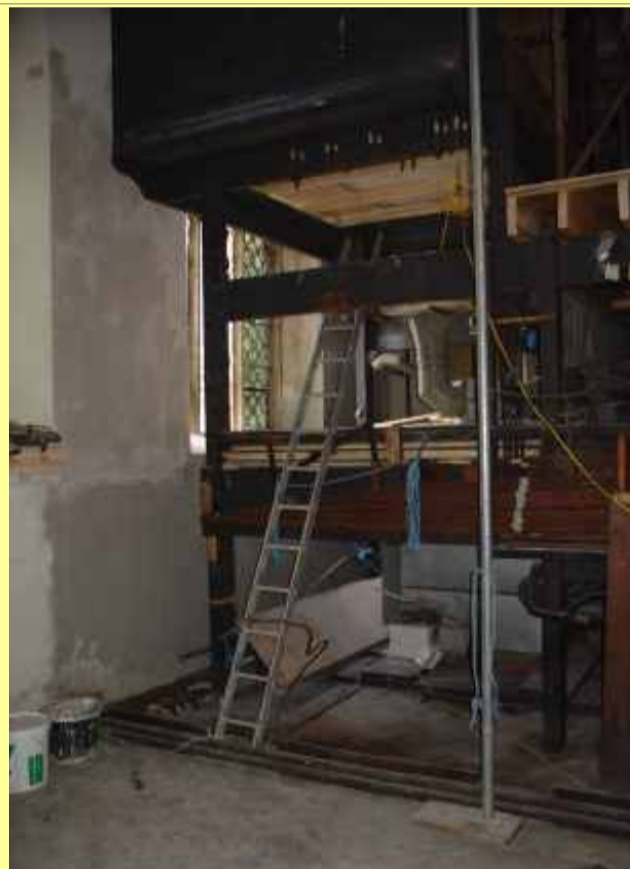
### 15th August 2004

Missing from this picture?

A bewildering spaghetti junction of wiring.

It has taken a couple of months work to re-site the distribution boards for the main electricity supply of the church, whose mains cable used to pass through the wall near the foot of the ladder in the picture opposite. The church was gas-lit when the organ was installed. The original church electricity supply distribution board was sited within the organ frame when organ blowing was electrified - posing for us a potential safety threat for the restored instrument.

Note the newly re-plastered wall - from which old gas piping, long redundant, had to be removed along with the mains electricity conduit - now moved six feet to the left, where the new state-of-the-art electricity distribution board has been located.

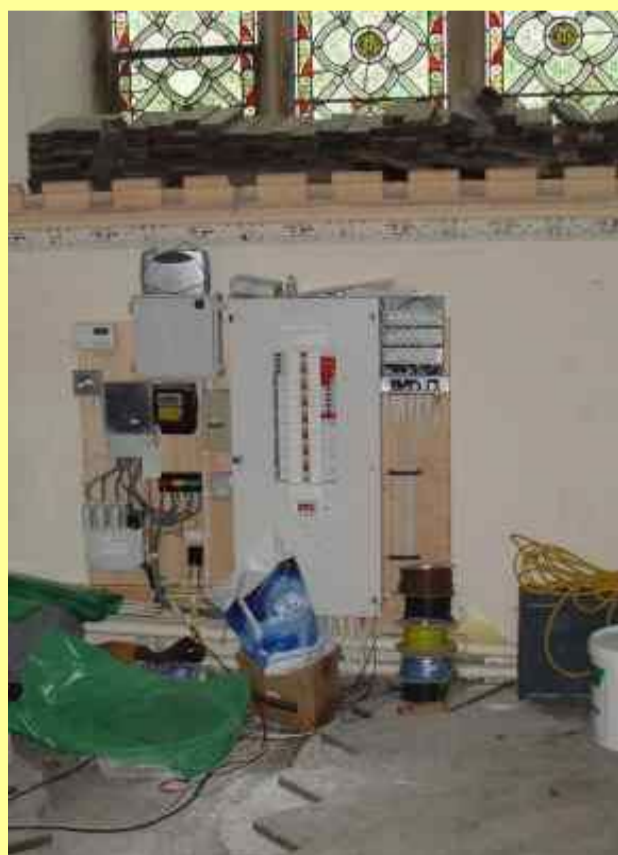
The new electricity distribution boards, and light switches for the chancel area. Power cables to boards in other parts of the church are being routed through a conduit underneath the woodblock floor.

When this was taken up to create a channel for the conduit, it was found that the wood blocks rest upon a six inch layer of mortar, which was laid in the late 1880s to cover grave stones set into the floor of this aisle.
