A Drive Unit for the Great Clock 3

Chris McKay, BSc CEng MIEE MBHI concludes his series.

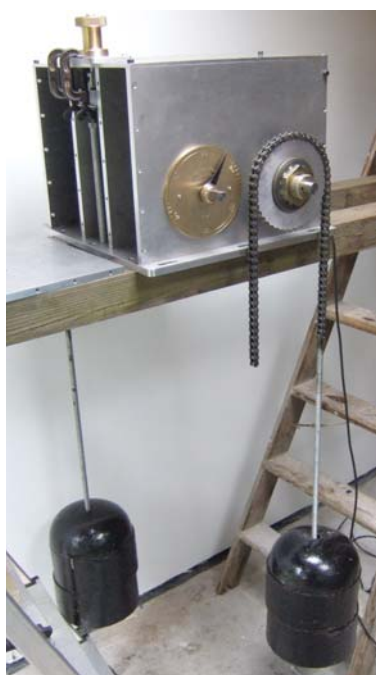
6. On test and lifting two weights totalling 2cwt.

Testing was an important part of the manufacturing process. The drive unit was securely clamped and turret clock weights added to both arbors to simulate the worst-case situation, **Photo 6**. Problems were experienced with insufficient output torque. All design calculations were checked but no error was found so the synchronous motor unit was suspected. Eventually a faulty phasing capacitor was identified. A replacement was swiftly supplied by the manufacturer, fitted and the drive unit just purred away and easily coped with the full-load test situation.
